**CPF 4-2018-5029S**

**NOTICE OF PROPOSED SAFETY ORDER**

Pursuant to Chapter 601 of title 49, United States Code, the Pipeline and Hazardous Materials Safety Administration (PHMSA) has initiated an investigation of the safety of Phillips 66 Pipeline, LLC's (Phillips 66 or Respondent), LO-01 or "Line-O," Pipeline in Elk, City, Oklahoma.

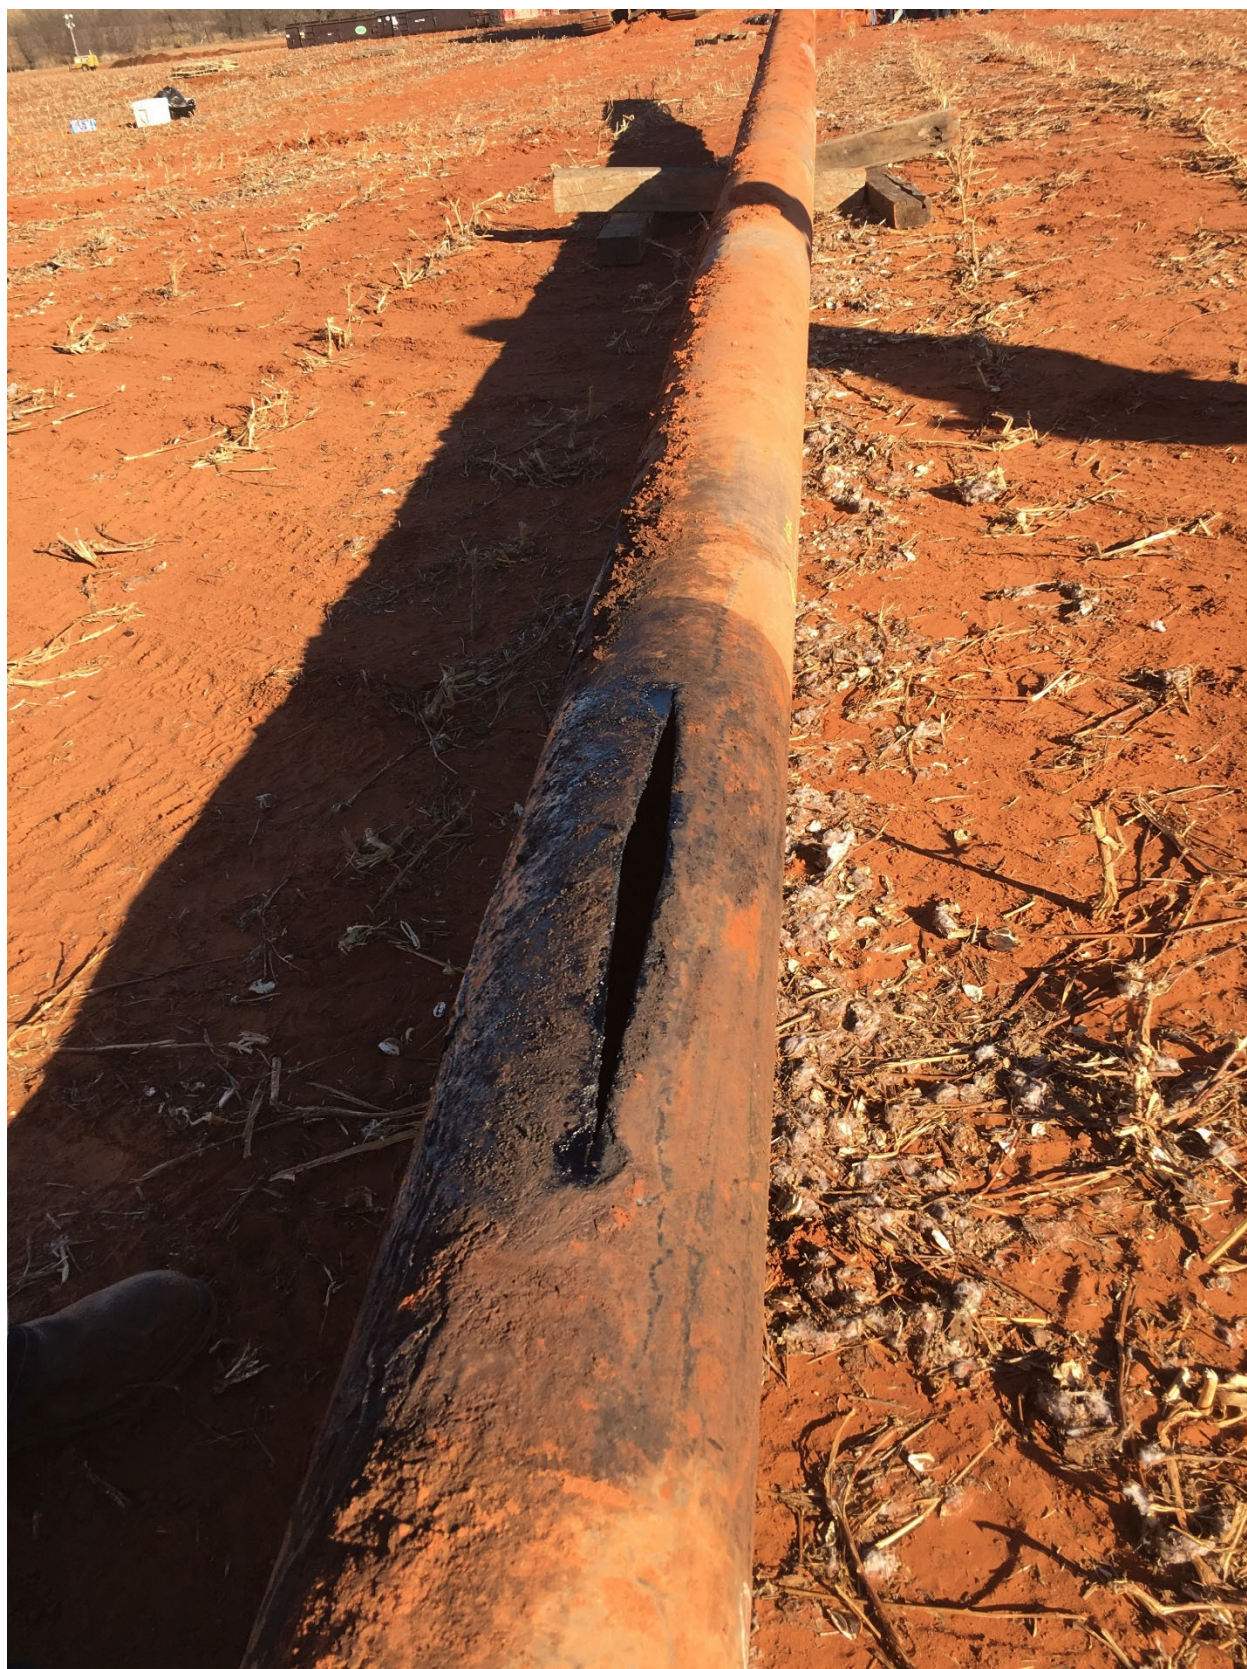
**Exhibit 1**

- The apparent cause of the release was a failure of the LF-ERW, longitudinal seam. The rupture of the seam was approximately 28.5 inches in length and 1.5-inches wide at the widest point.<sup>2</sup> It is estimated that approximately 672 barrels of crude oil were released as a result of the seam failure.

- On December 1, 2018, Phillips 66 repaired the pipe segment that ruptured on November 29th. Three joints of pipe were cold cut and removed. Three new joints of pre-tested pipe were then welded in place. Phillips 66 conducted a two-hour standup test on December 2, 2018. Phillips 66 also provided PHMSA with a repair plan with associated procedures to address the repairs performed along with a restart plan. The line returned to service on December 2nd at reduced pressure levels on each segment to coincide with a 20% total pressure reduction on the LO-01 Pipeline.
